HISTORIC AMERICAN BUILDINGS SURVEY
INVENTORY

2. NAME *Orrin Thompson Mansion*

DATE OR PERIOD *1832*
STYLE *Greek Revival*
ARCHITECT
BUILDER *Orrin Thompson*

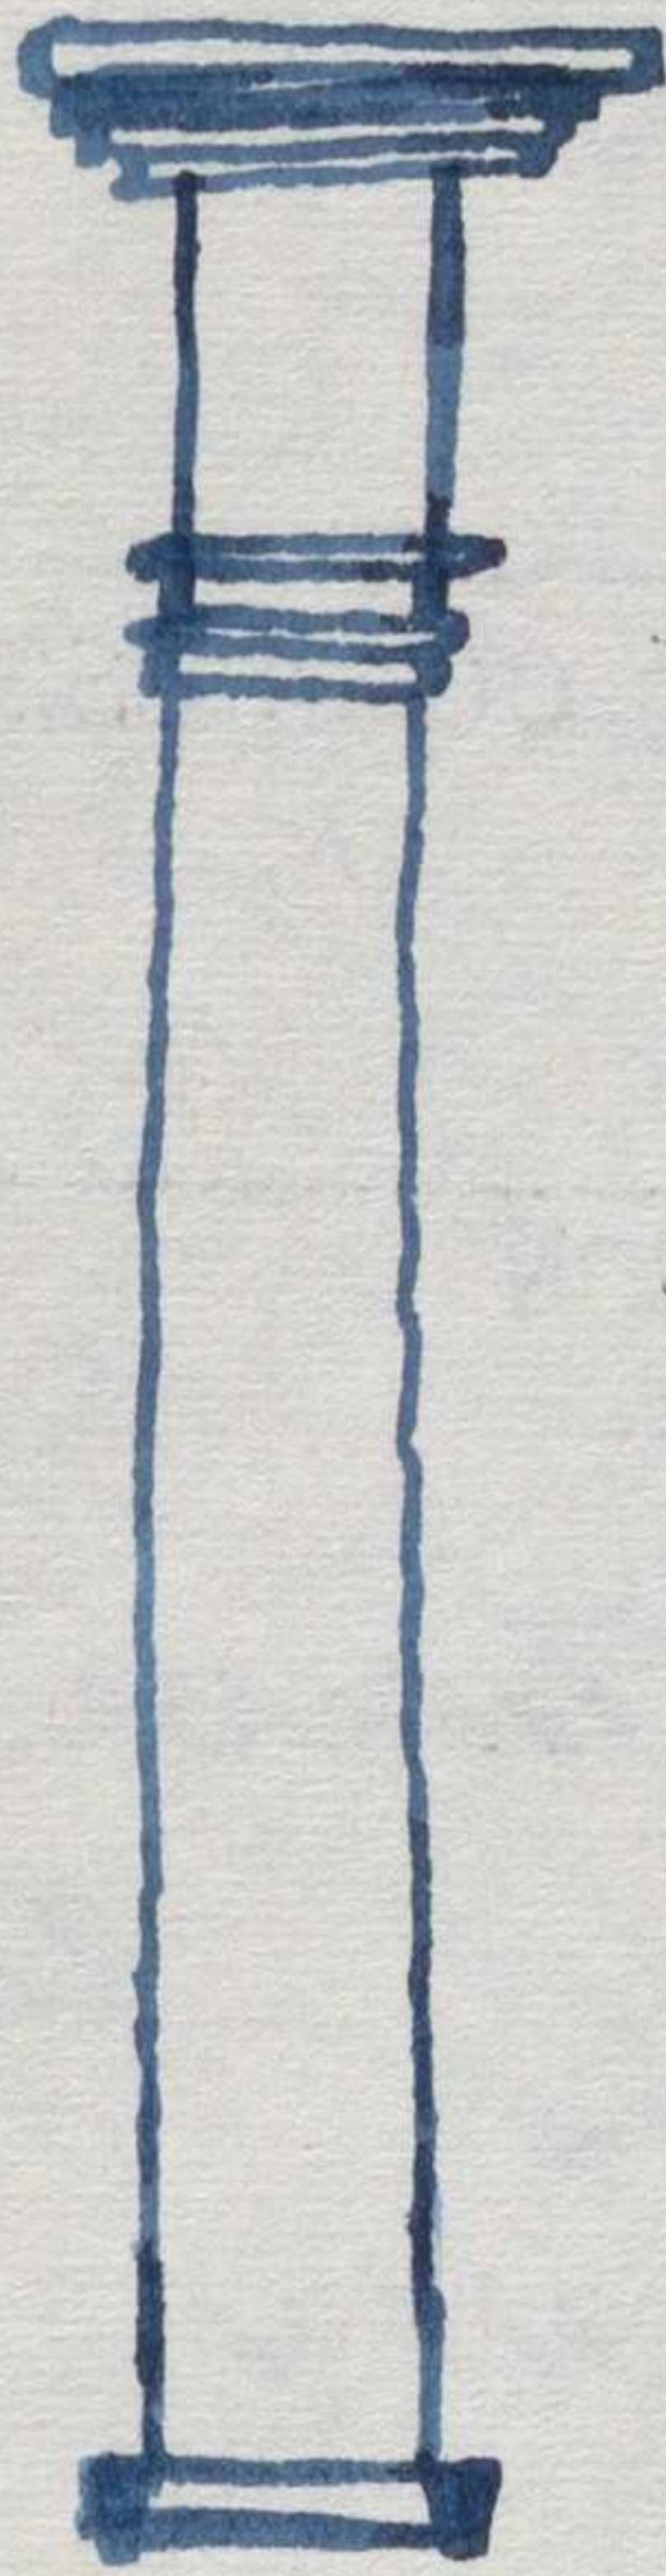
corner pilaster

The ell shaped plan of this house is typical of its period throughout the country. The three bay, two story portion has a facade with pediment, its east wall being connected to the 1 1/2 story 4 bay wing of opposite direction. The latter has a charming Greek doric porch in front of its two western bays. The foundation of the main section is brown stone, the wing brick. The house has plain Doric pilasters at its corners, heavy plain entablature, and characteristic simple period doorway. Over

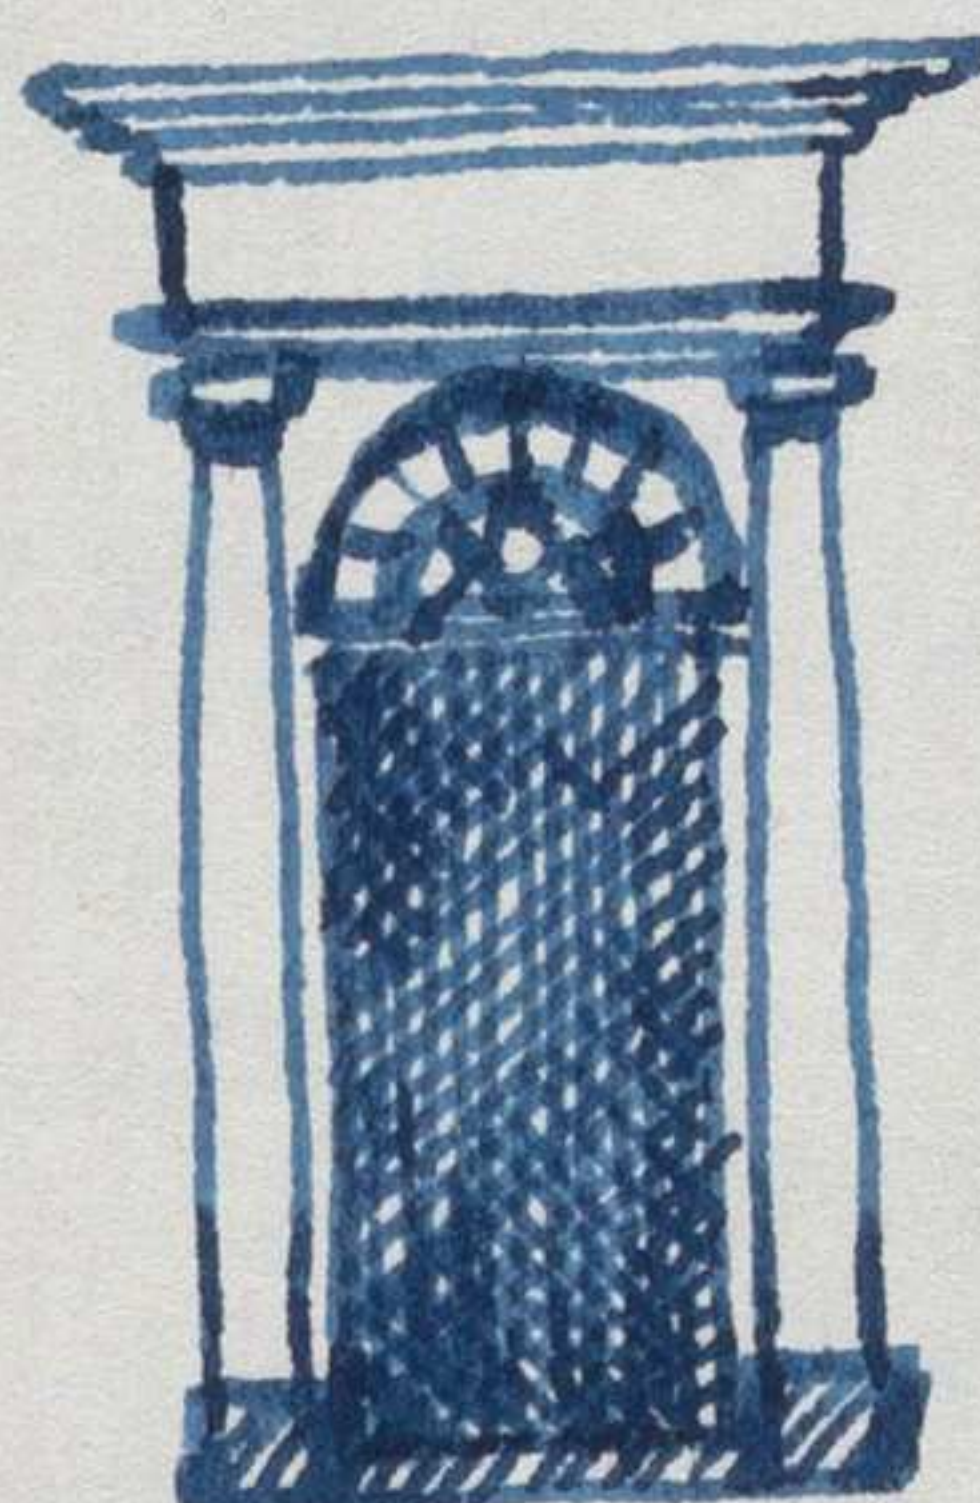
This house is quite fine. The facade is in three bays, resting on a brown stone foundation and capped with a fairly shallow pitched roof. The pediment with fine definite molding, plain flush boarding and a rectangular 1860 vintage window. The doorway is the house's finest feature.

The plain entablature is supported by simple pilasters tapering to brownstone plinth blocks. The semicircular transom is of a design common to many Enfield houses.

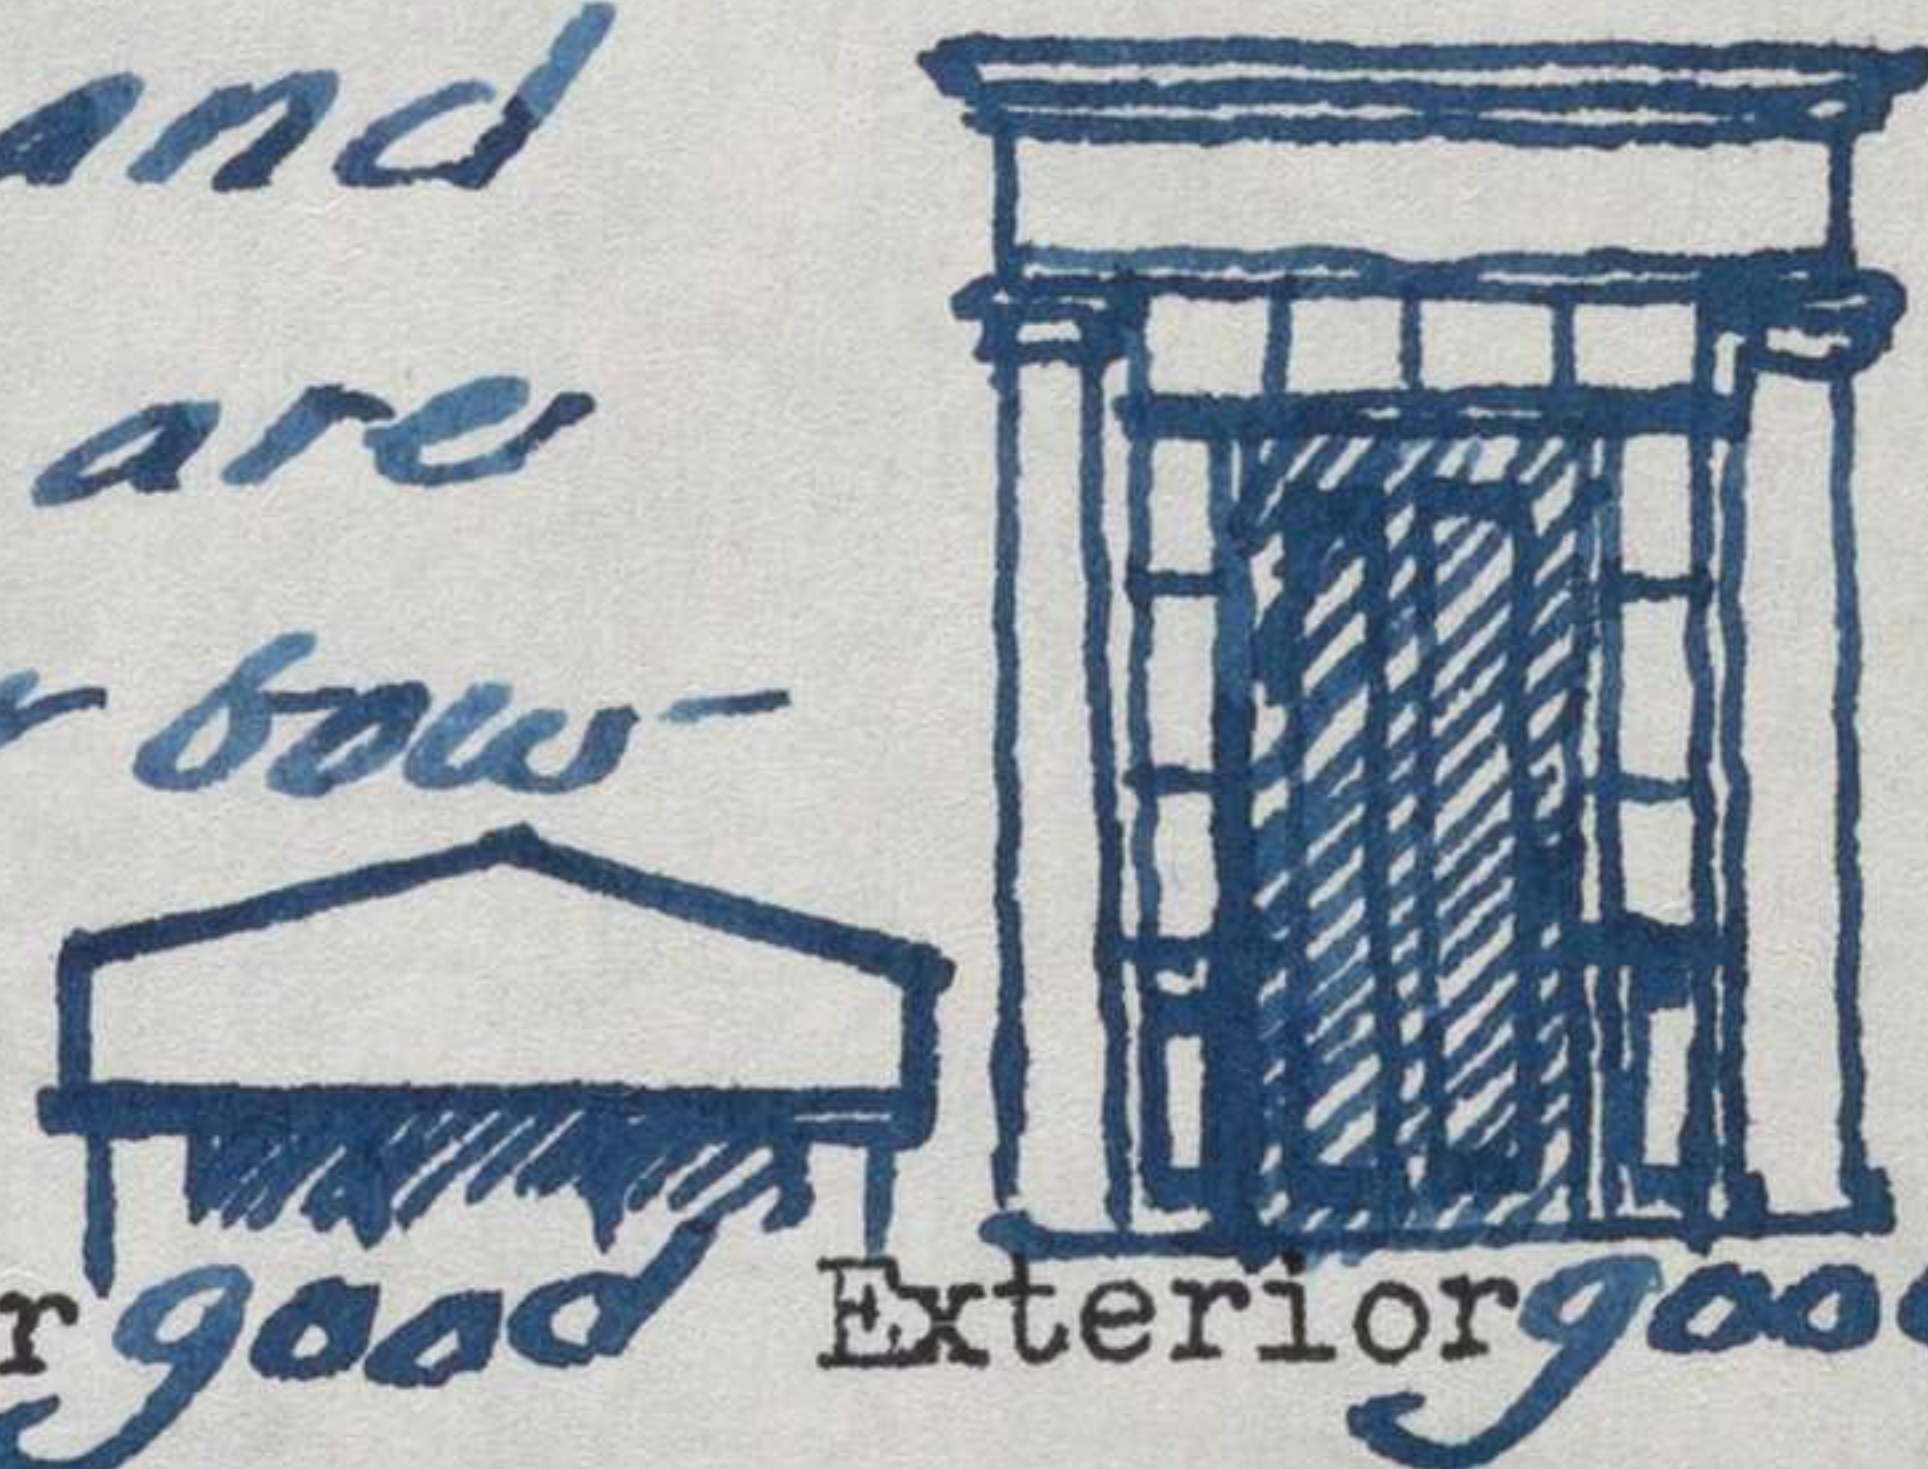
This house has a large southern addition but the original is quite fine and the whole is in fine condition. The original portion has a facade of three bays built on a brownstone foundation and topped with an accentuated pediment formed by a shallow pitched roof. The corners are ornamented with plain pilasters and eaves are born on a simple full entablature as is the pedimental window which is shuttered over and the front door which has both transom and side lights. The first floor windows are capped with slant topped lintels. Mr Bowdy said the house is of peg construction.

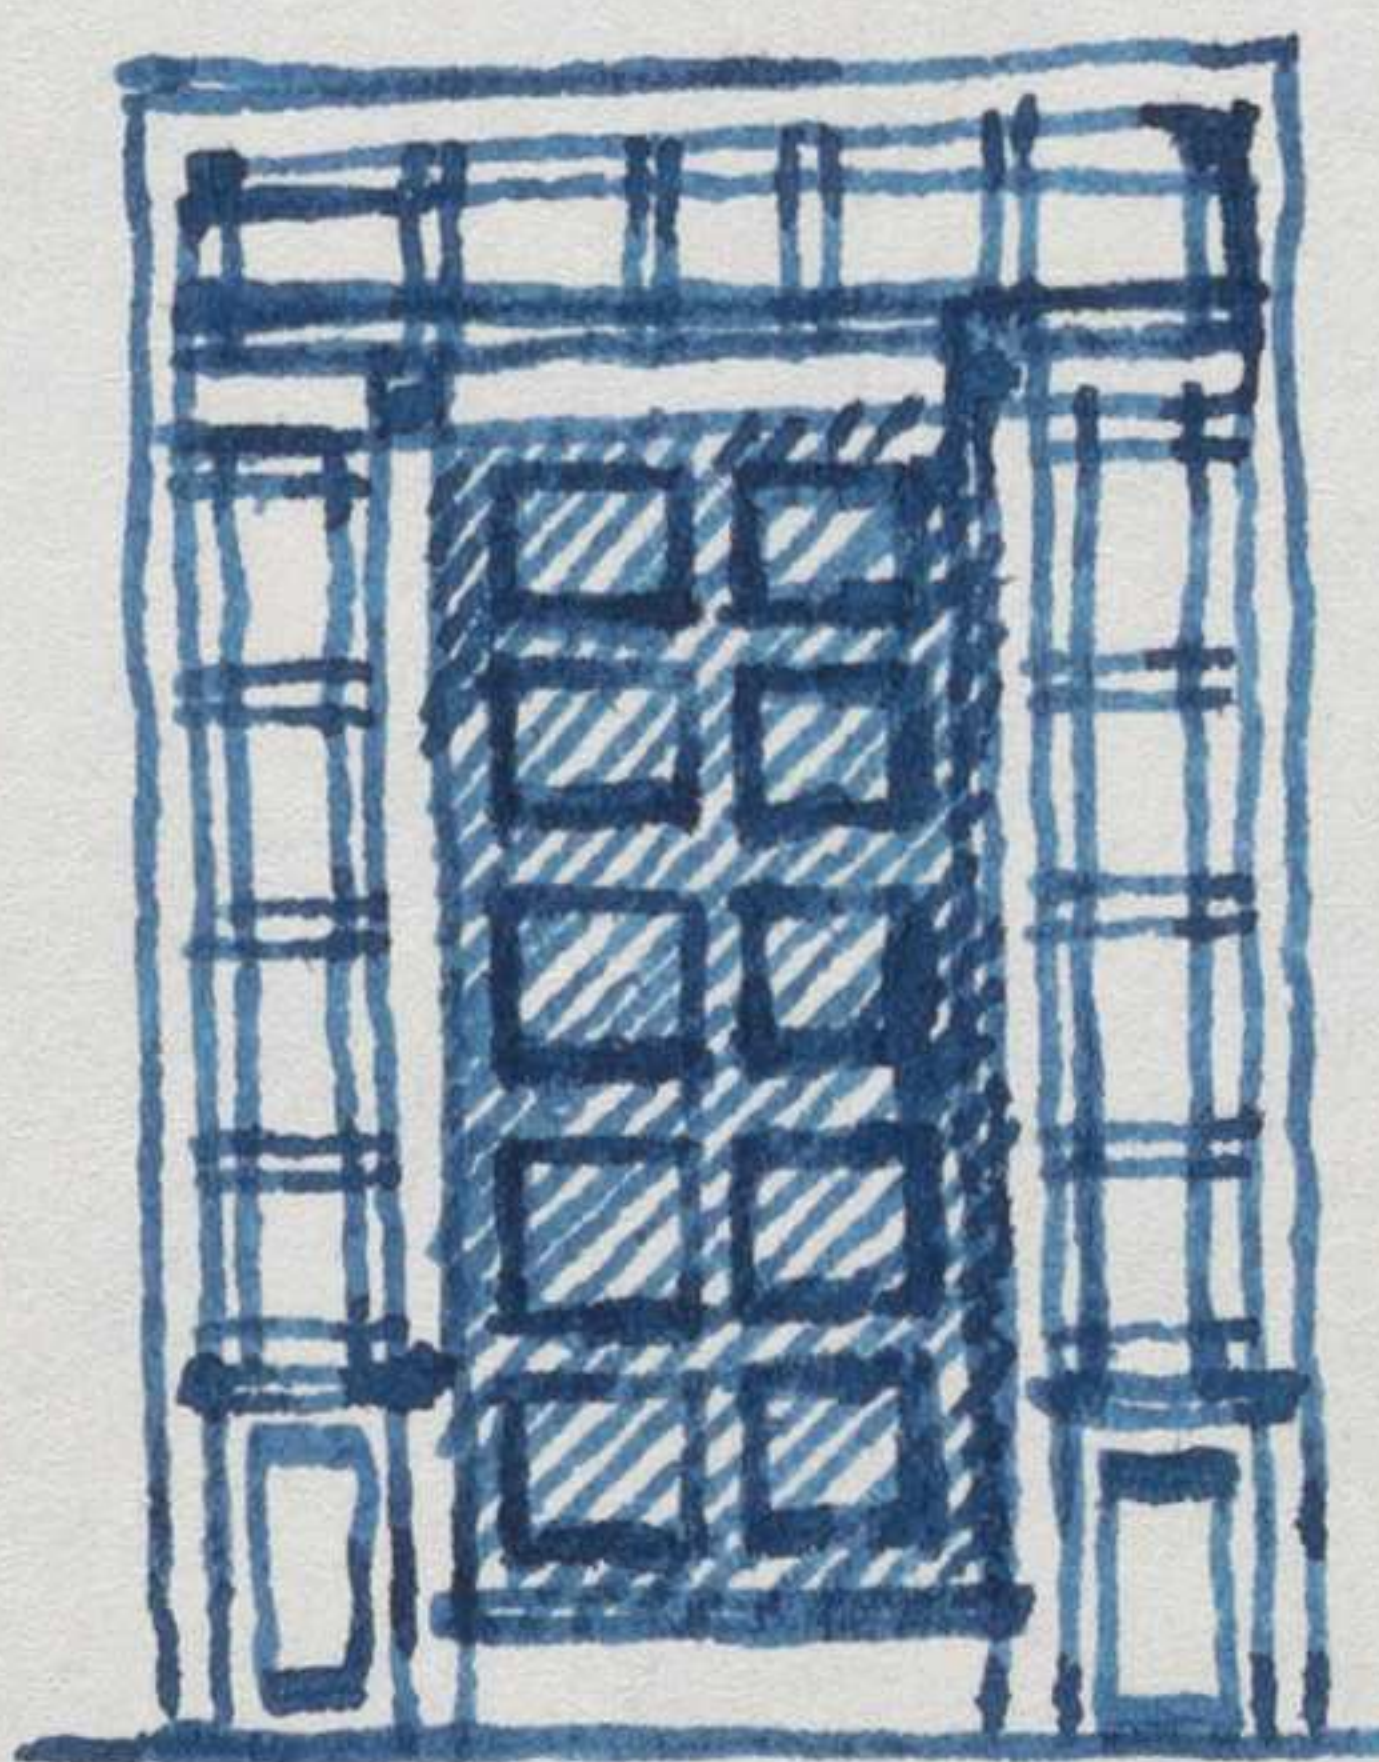
This is a fine house, but very badly altered. It is in the form of a five bay facade with brownstone foundation and shallow pitched roof. The central chimney is not original ~~but~~ and there is but one original window in the attic which is a 12/8. The doorway of the early 19th century is the finest feature and with its door is mercifully preserved.

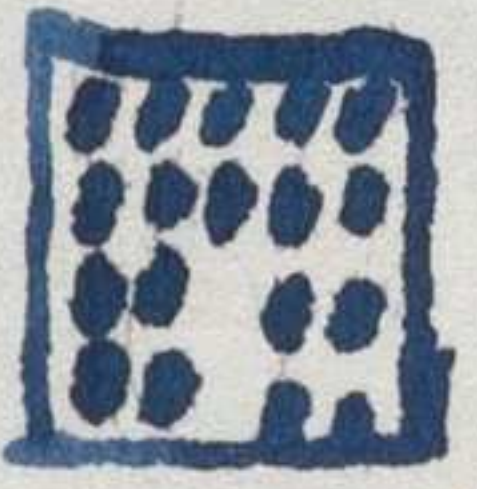
This house has the finest detailwork of any house in the south east area of Enfield. Its five bay facade is built on a brownstone foundation and bears a shallow pitched roof. There are two central chimneys are placed in elevation between the 1st and 2nd and the 4th and 5th bays. The beautiful cornice which decorates not only the triangular side pediments but the facade as well is made up of squares of guttae.

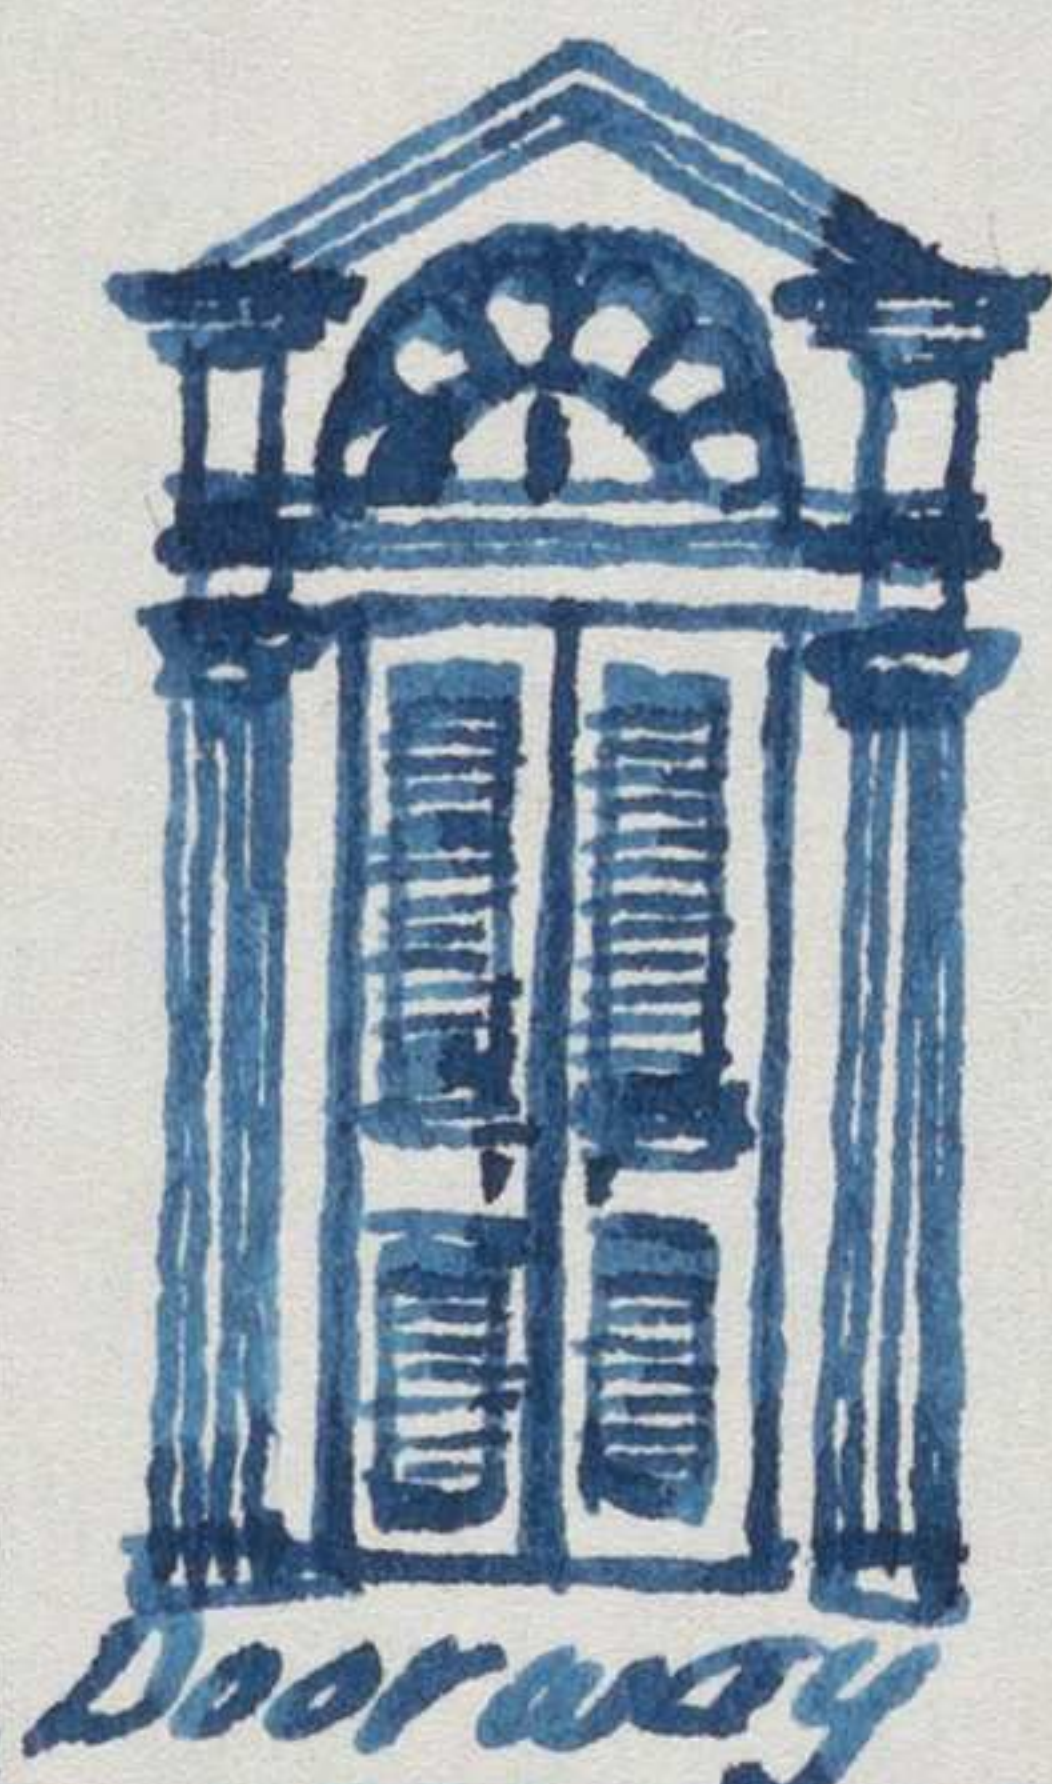
Doorway

The doorway is made up of a magnificently leaded semi-circular transom inscribed in a triangular pediment. The supporting members are fine fluted pilasters supported on plinth blocks.

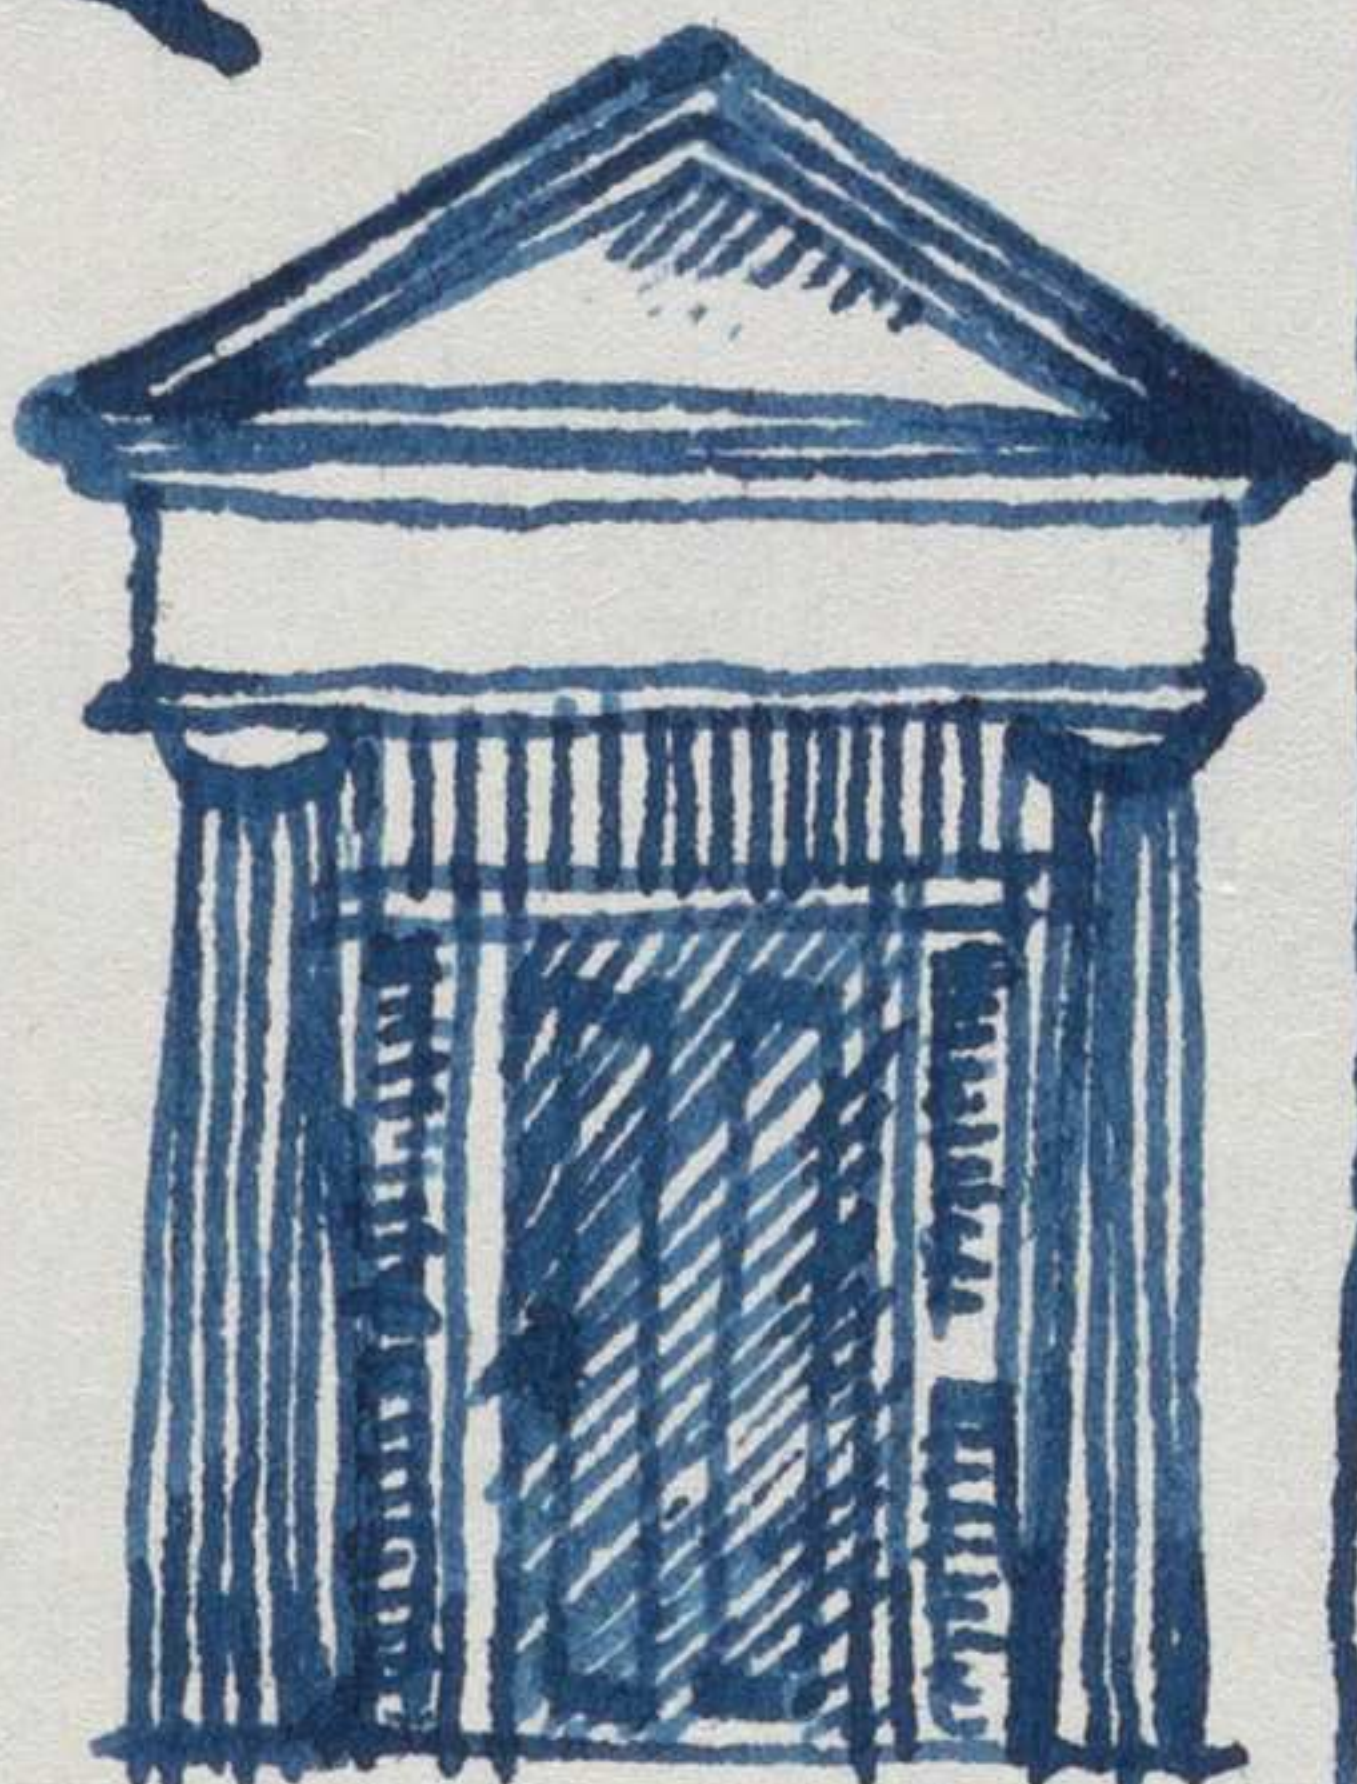
Doorway

This five bay house is built on a cut brown-stone foundation. Its roof is low pitched and bears two central chimneys on its ridge pole in the usual positions. There are paneled corner pilasters and 6/6 windows. The doorway is quite fine and is framed in triangular pedimental portico with fine doric columns. The door's transom is divided into 18 pieces and the side lights are shuttered.

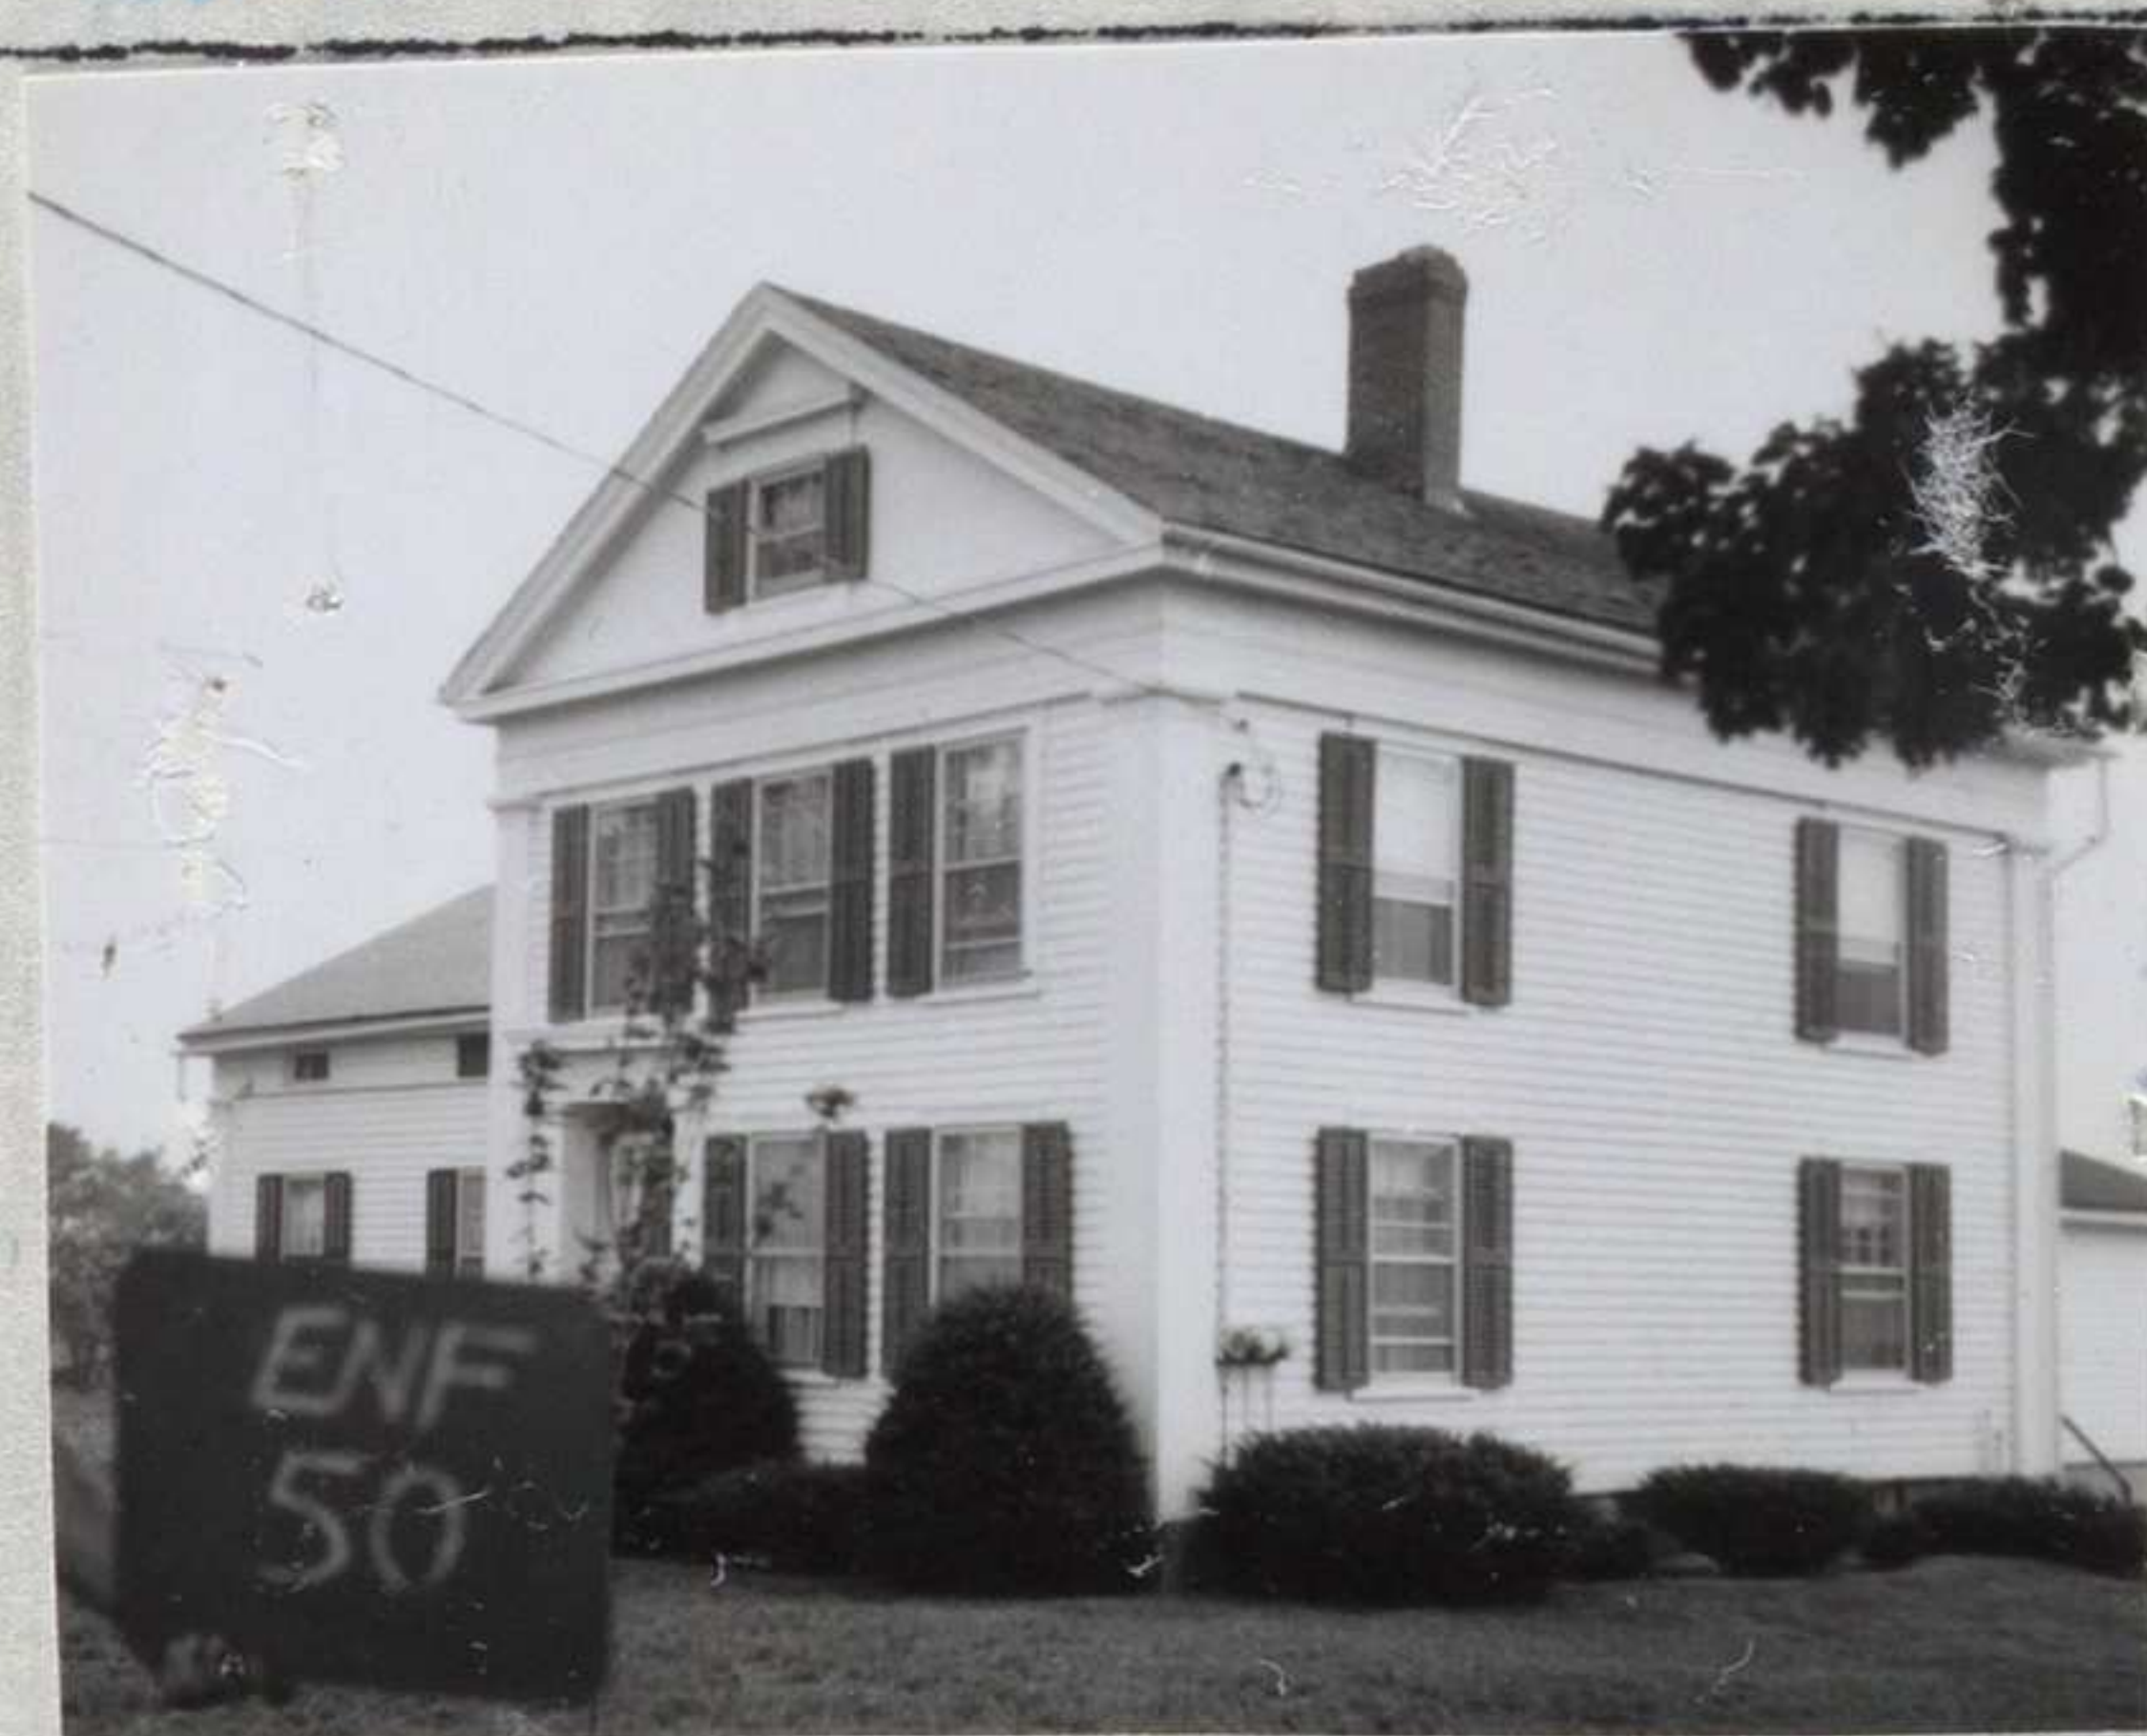
7. PHOTOGRAPH *Enf 50*

This shallow roofed house is in three bays built on a brownstone foundation. The corners are accented with plain pilasters, the pediment with a square rectangular window. The doorway echoes the plain pilasters and simple entablature of the house. To the south a recessed porch in the 1 1/2 story ell has been too greatly changed to retain its original flavor.

Interior *fair?*

Exterior *fair*

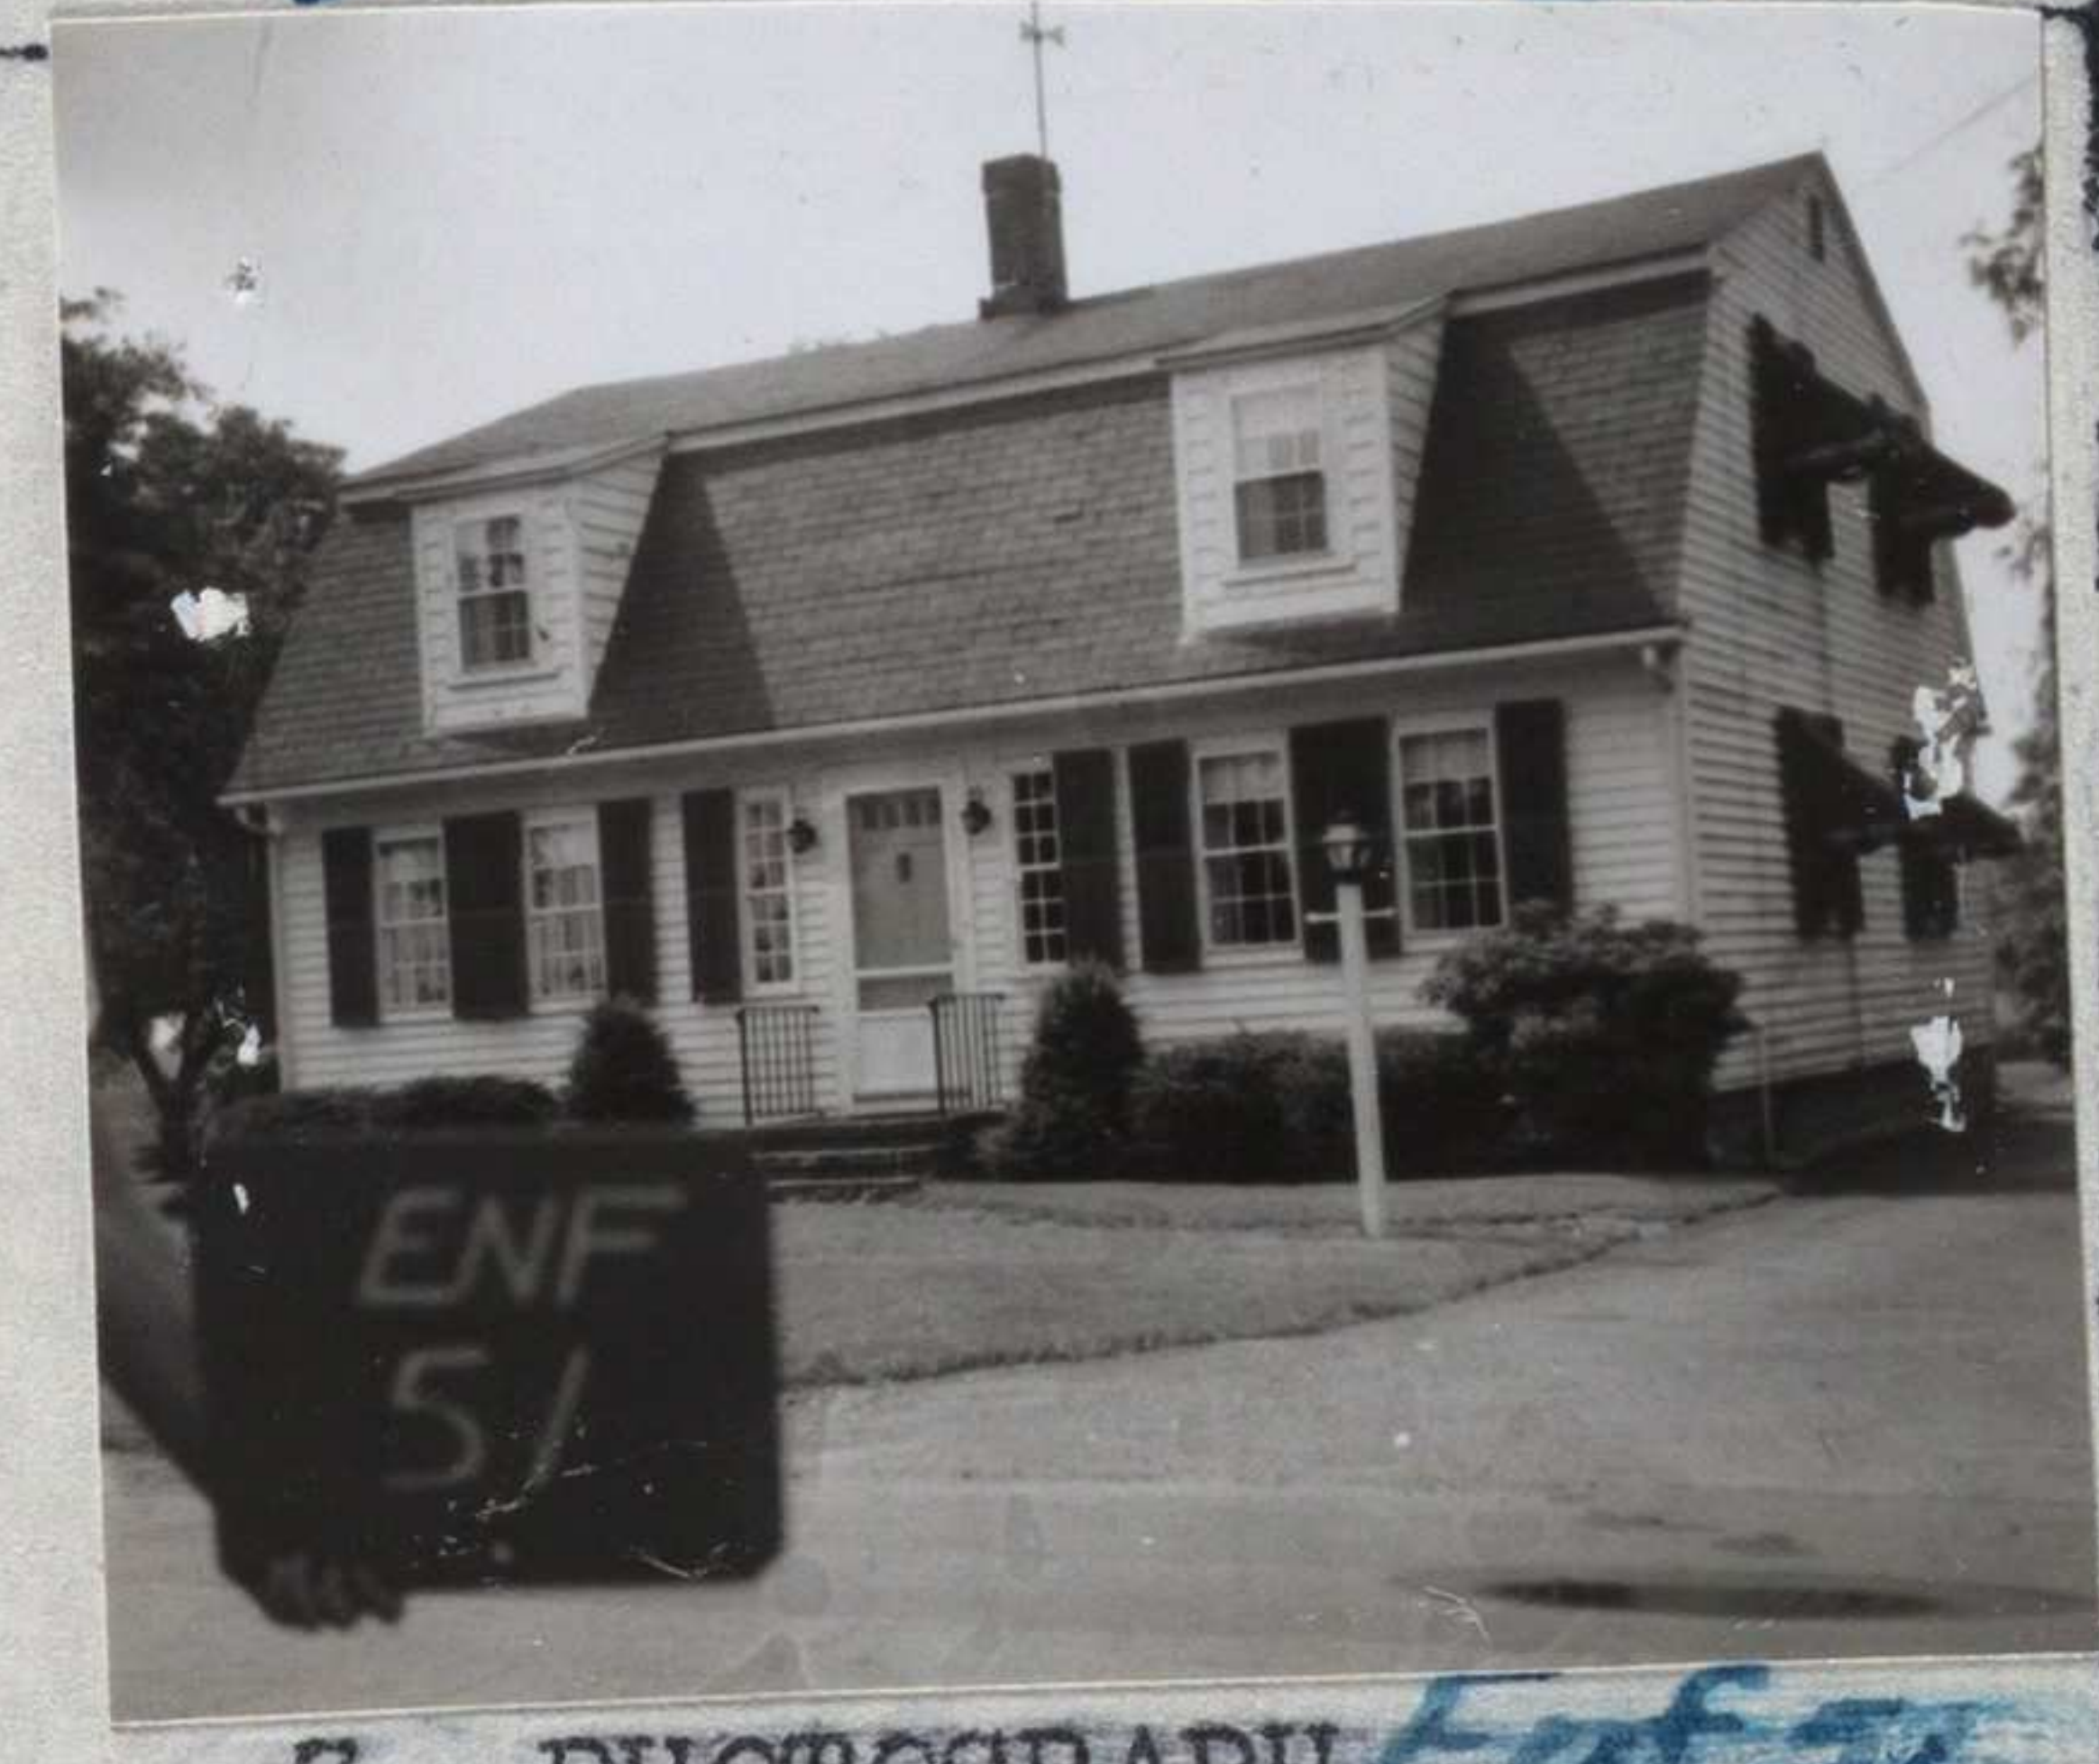
7. PHOTOGRAPH *Enf 51*

This fine old gambrel house was moved about 40 years ago from Enfield Street at the site of the present Atlantic station, two houses south of No. 53. It is one of only three gambrel roofed houses or portions of houses found about Enfield. It is of the typical Ct gambrel form shown in Kelly's book (figure 135). It is in five bays with a central chimney. There are additions including dormers; however, the basic fabric is nearly entirely complete. The doorway is particularly interesting in that it is different from any other seen in the area, being much more like the Virginia or Maryland type with its side lights totally separate from the doorway.

Endangered *No.* Interior *good* Exterior *good*
